MEMORANDUM

SUBJECT: Schicke Point Field Visit Report, March 17, 2023

DATE: March 20, 2023

PROJECT: MBF21580

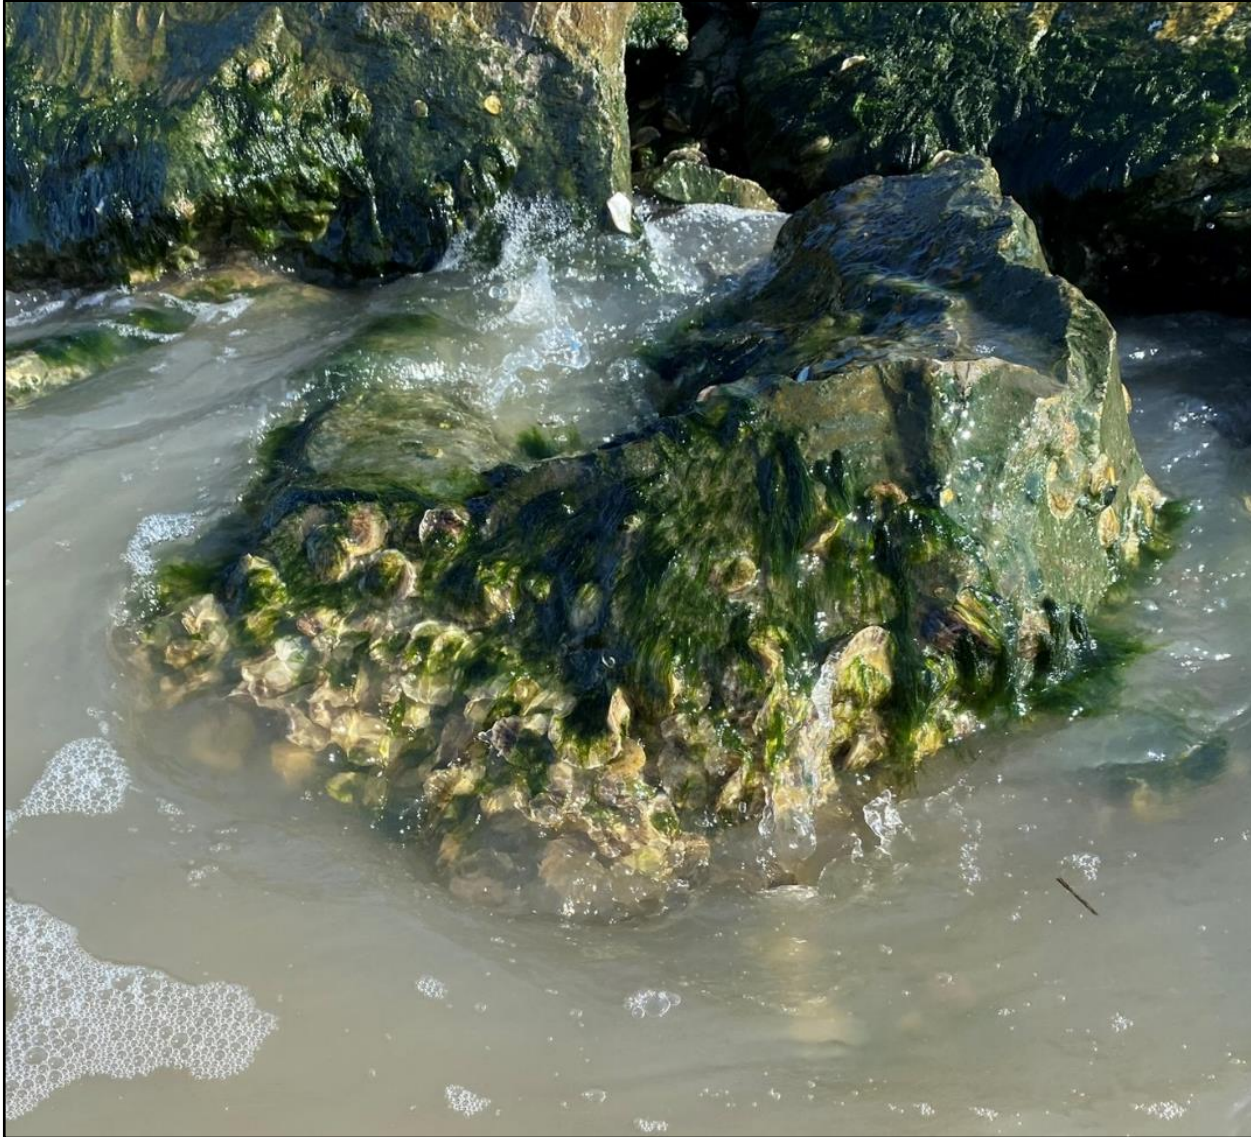
There were no visible obvious changes in the shape of the living shoreline. The green alga, *Ulva flexuosa*, covered much of the tops of the top rocks. High densities of acorn barnacles were colonizing the bay side of the living shoreline. Eastern oysters, up to 1.5 inches long, were abundant on vertical and near vertical surfaces of rocks along the shore side of the living shoreline (Figure 2). Oysters were also colonizing the undersides of rocks. Each rock that was turned over had one to three oysters living on the bottom of the rock (Figure 3). Oysters had colonized surfaces near the top of the living shoreline. Serpulid worms were also colonizing part of the living shoreline.

Figure 2. Shore-facing rocks of Schicke Point living shoreline constructed in August 2022 demonstrating oyster colonization. Photo taken by FNI on March 17, 2023.

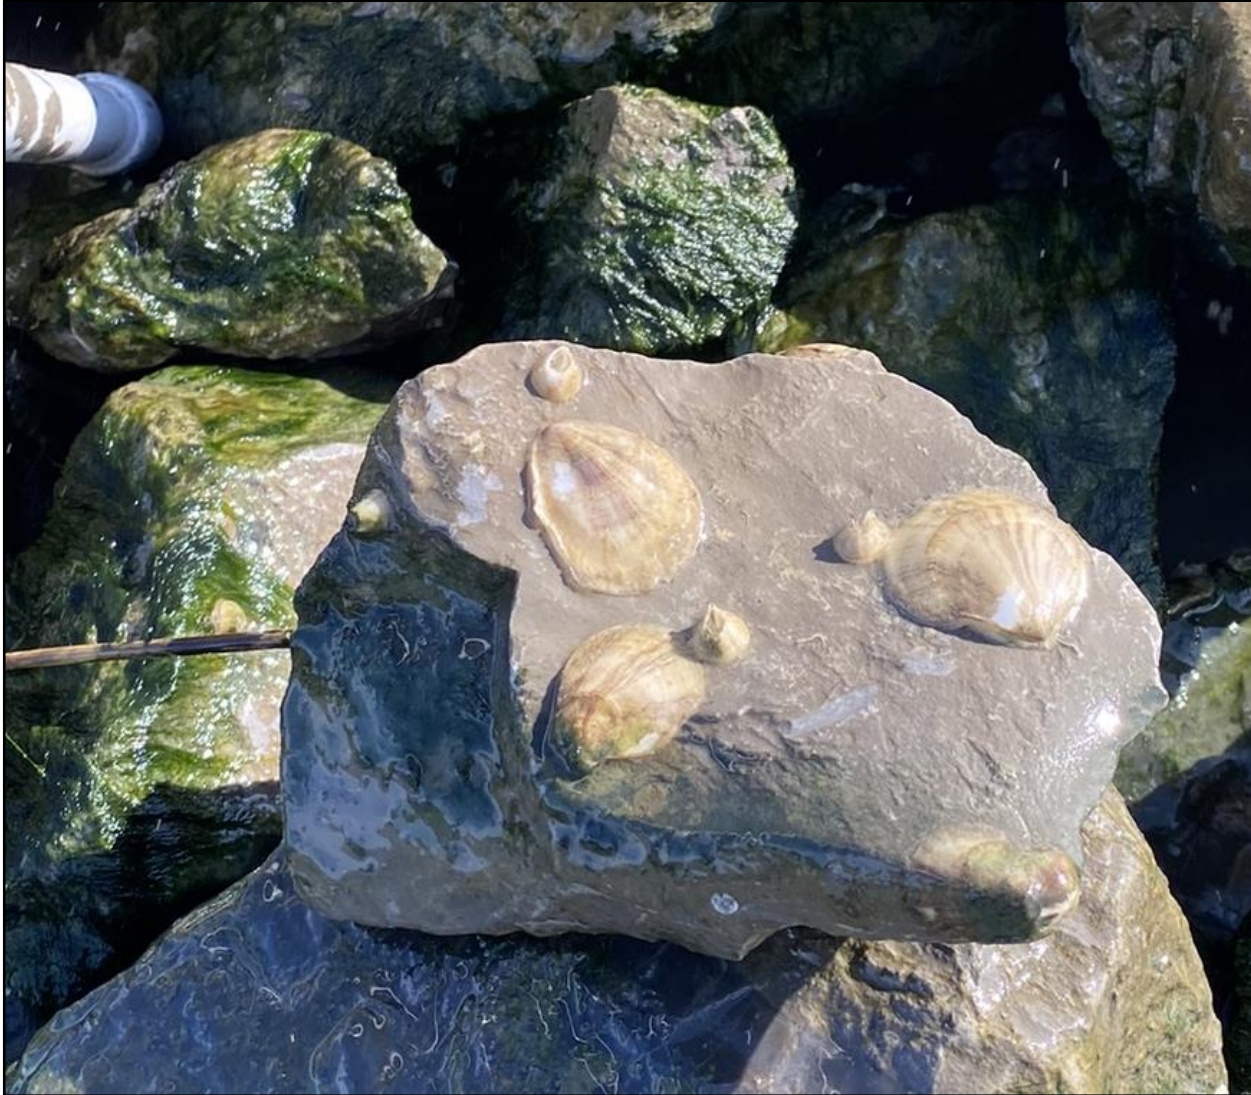
Figure 3. Shore-facing rocks of Schicke Point living shoreline constructed in August 2022 demonstrating oysters colonizing the bottom of a rock in the living shoreline. Photo taken by FNI on March 17, 2023.

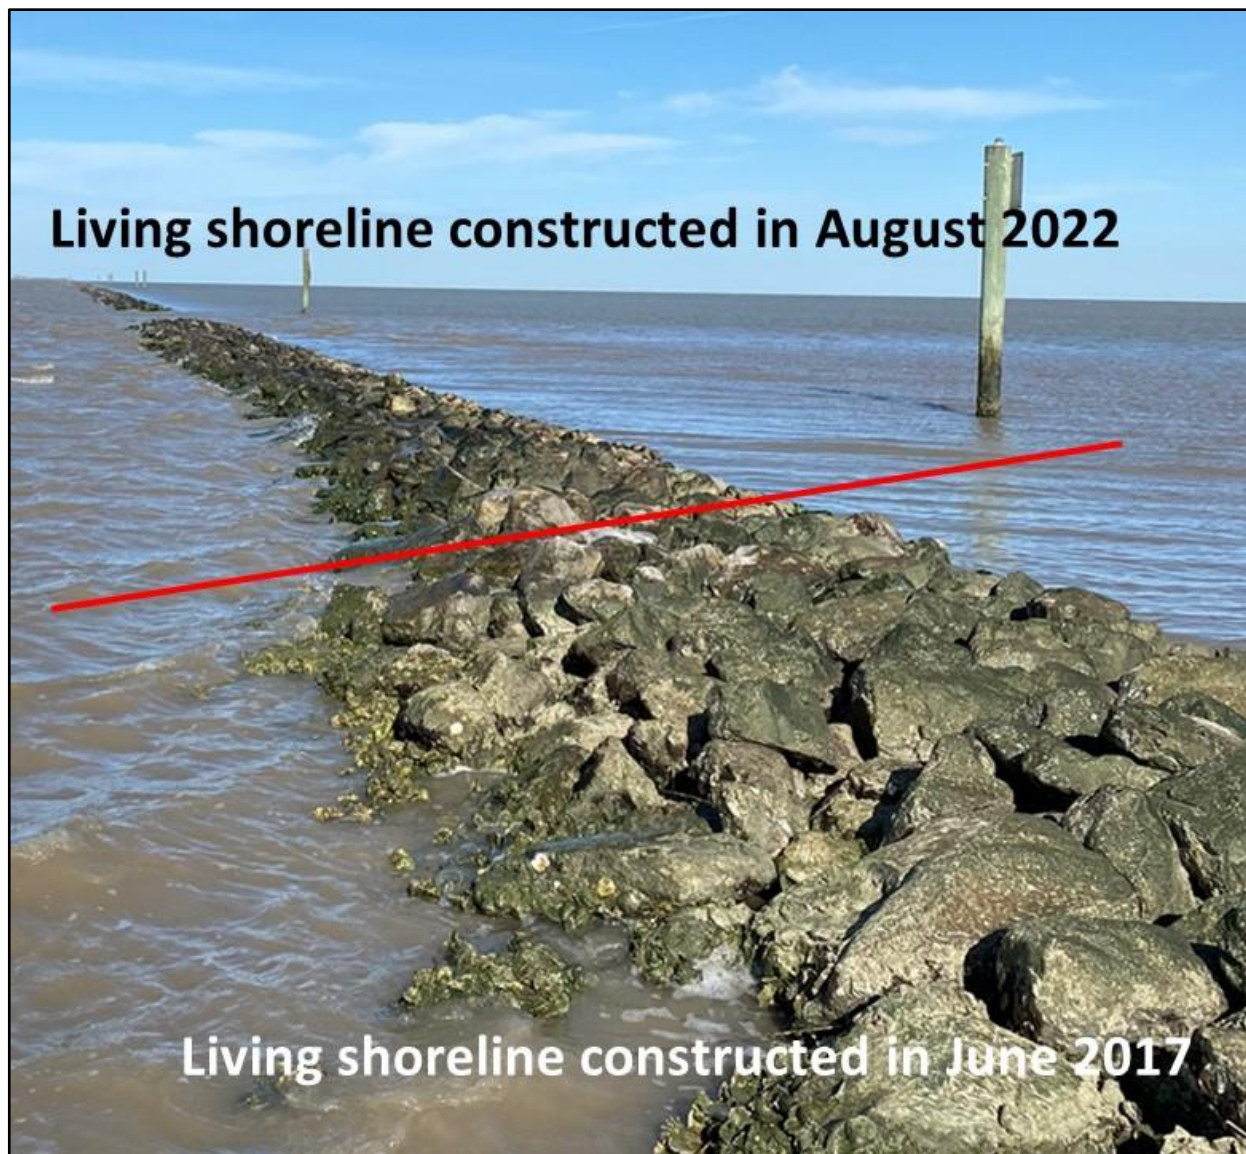
Figure 4. Schicke Point living shoreline where the portion constructed in August 2022 (above the red line) connects to the portion constructed in June 2017 (below the red line). Note oysters colonizing the older reach of living shoreline. Photo taken March 17, 2023 by FNI.

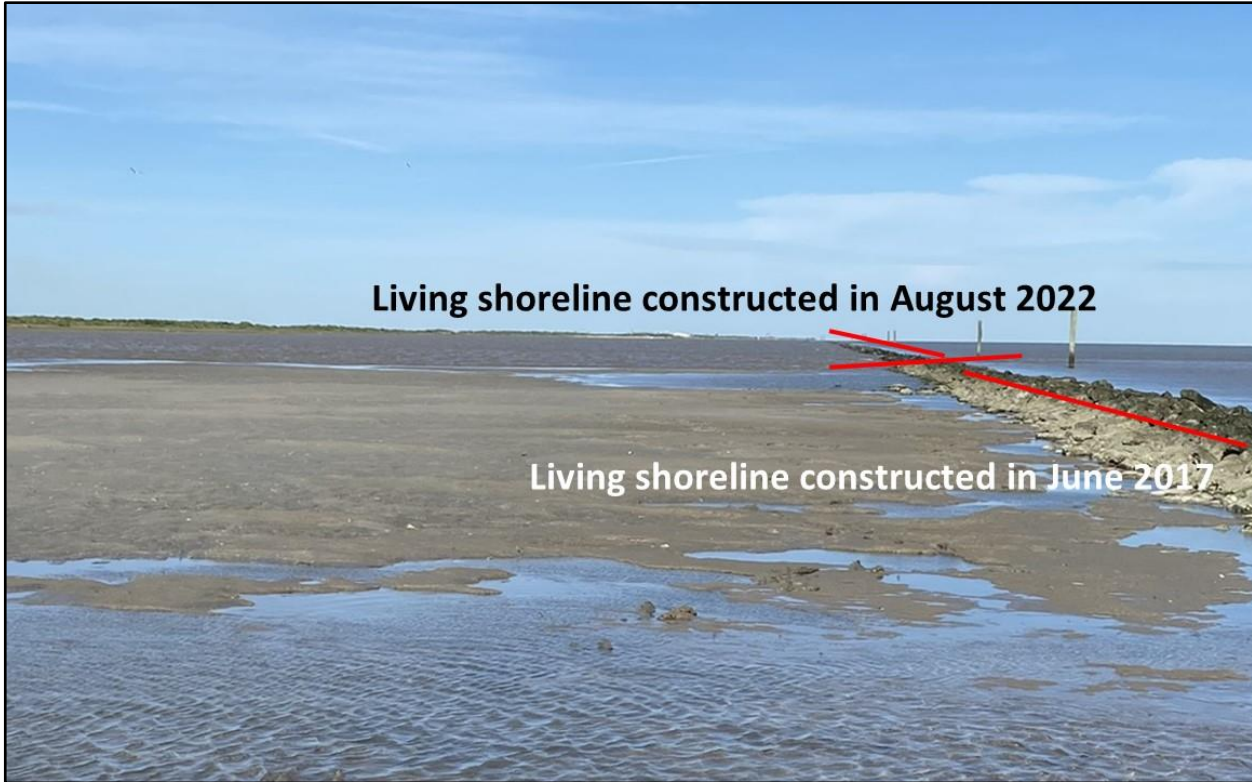
Sediment had accumulated along the shore side of the living shoreline up to a depth of a foot or more around the center of each section of living shoreline. There was no soft sediment around the gaps between each section of living shoreline.

Figure 5. Schicke Point living shoreline where the portion constructed in August 2022 (above the red line) connects to the portion constructed in June 2017 (below the red line). Note sediment accumulated behind the older reach of living shoreline. Photo taken March 17, 2023 by FNI.

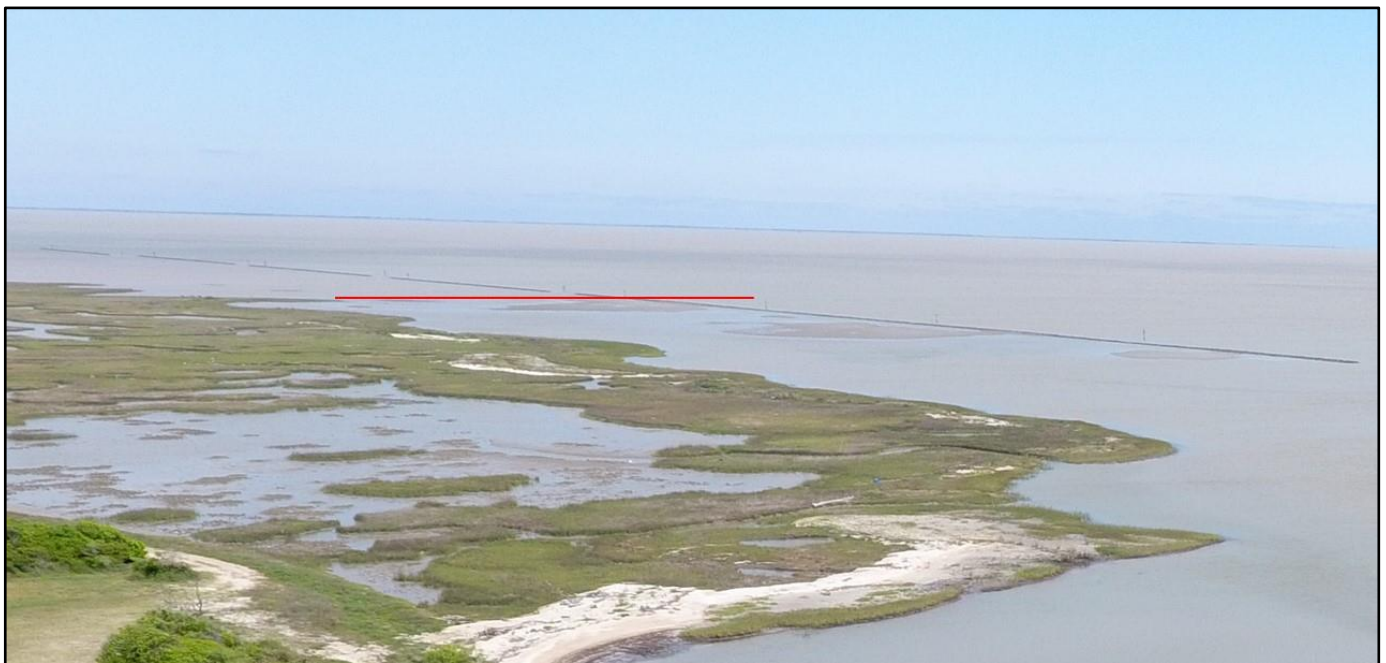
Figure 6. Schicke Point living shoreline where the portion constructed in August 2022 (above the red line) connects to the portion constructed in June 2017 (below the red line). Note sediment accumulated behind the older reach of living shoreline. Photo taken March 17, 2023 by FNI.

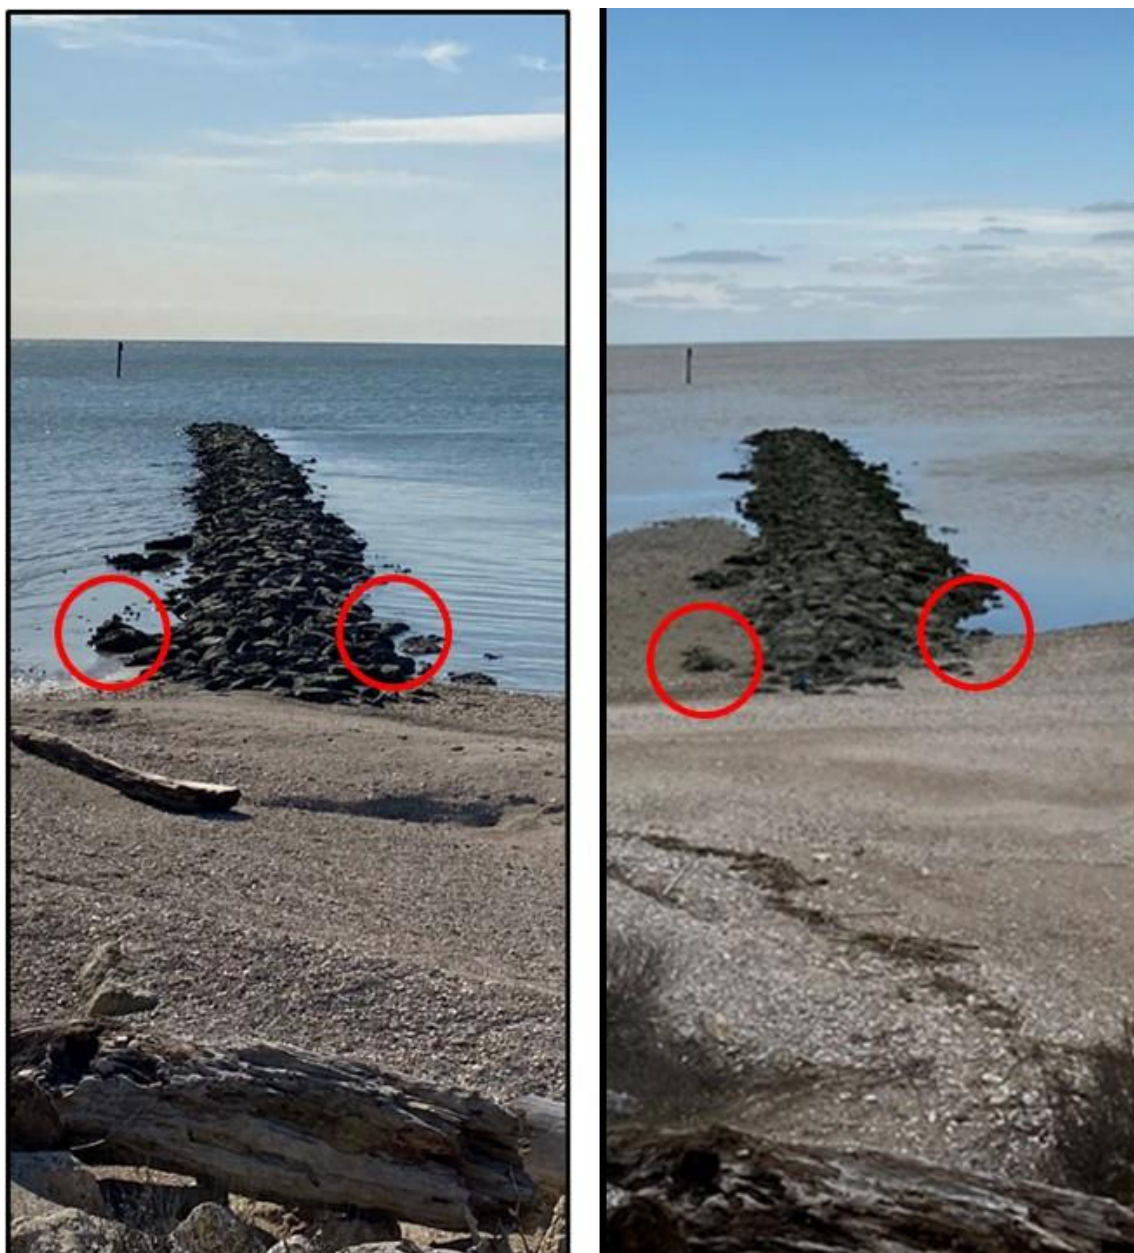
Figures 2 through 6 illustrate the new living shoreline. Figure 7 shows the continuing accumulation of shell hash around the terminal groin of the Schicke Point living shoreline constructed in April 2017.

Figure 7. Terminal groin of Schicke Point living shoreline constructed in April 2017. Image on left taken on January 11, 2022. Image on right taken March 17, 2023. Red circles include rocks visible in both photos. Water level at Port Lavaca on January 2022 was 0.58 feet higher than on March 17, 2023. Water level at Port O'Connor was 0.15 feet higher on March 17, 2023 than when the photo was taken on January 11, 2022.
